# Caterpillar HTK0973 SOA Engine Review

**Newmont USA, Ltd**  
**Asset Management**  
**Fluids Management**  
July, 2017

## HTK0973 Engine History

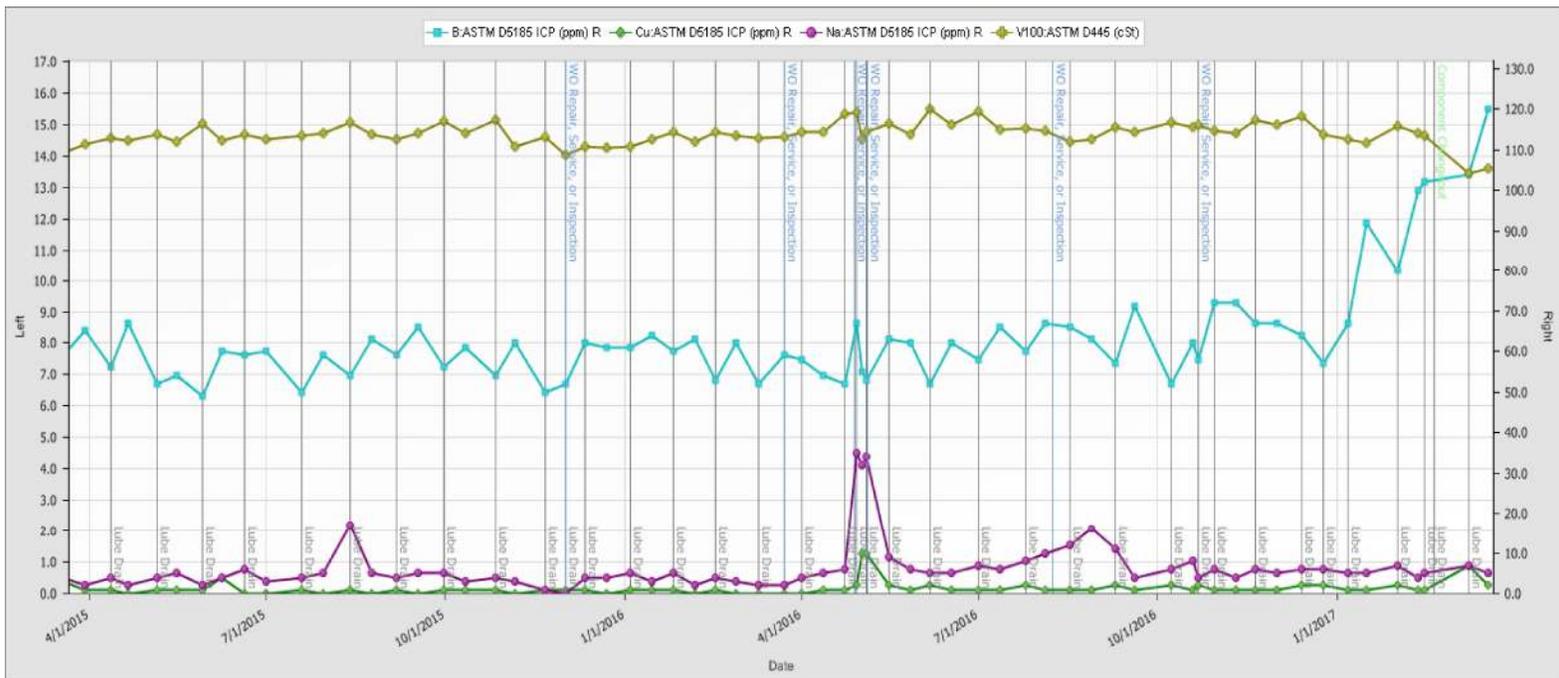
Note from author: The increase in Boron on the last four samples before engine removal was due to a change in base engine oil additive chemistry from the supplier, not from a coolant leak. The last two samples on the slide above is due to engine oil chemistry received from the engine rebuilder following install of the replacement engine for the SOA engine..

**Note:** P66 Guardol ECT (Ti) 15w40 engine oil formula change effective approx. Jan 15, 2017 can be seen by increase in Boron after this date in the Coolant trend view.

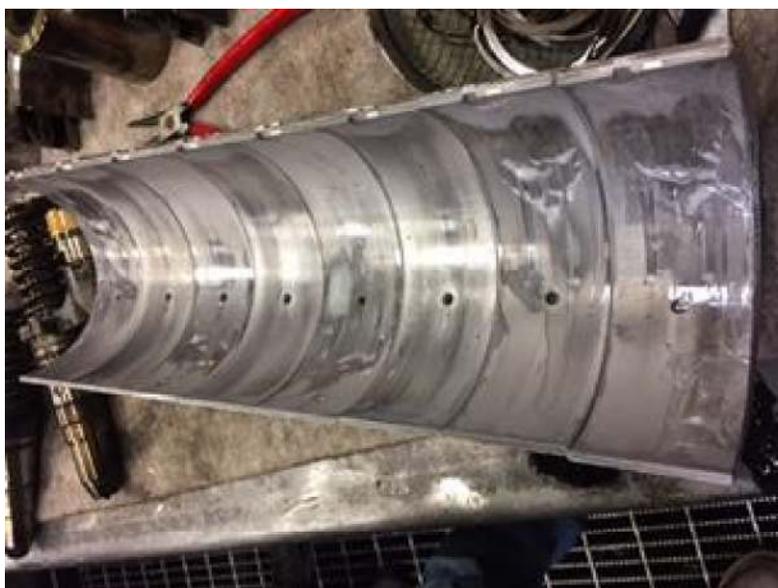
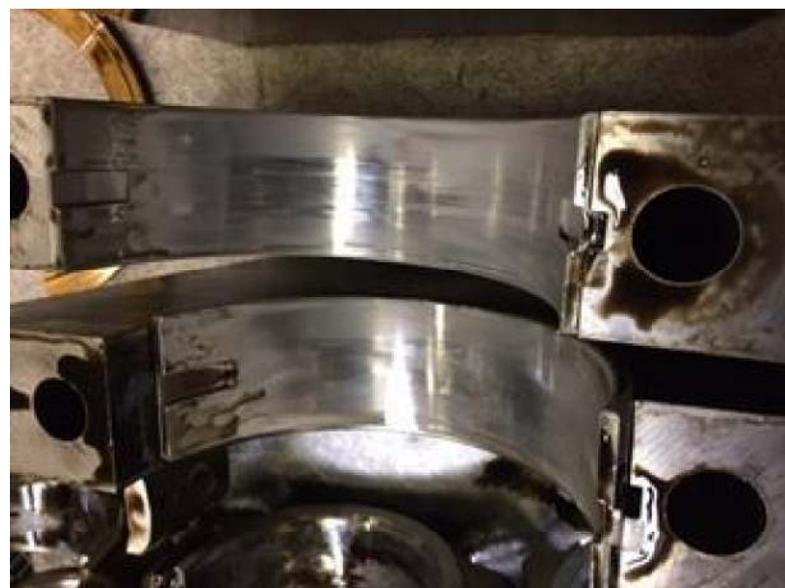
## Photos at Engine Disassembly (bearings)

- multiple broken re-used head bolts and subsequent head gasket leakage;
- and, cautionary replacement of all crankshaft rod & main bearings with updated bearing materials;

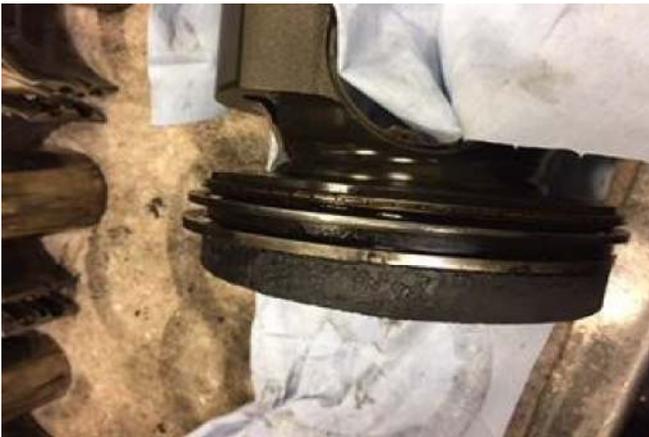
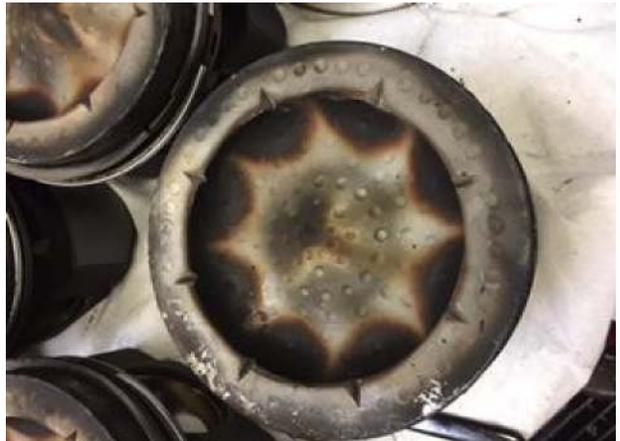
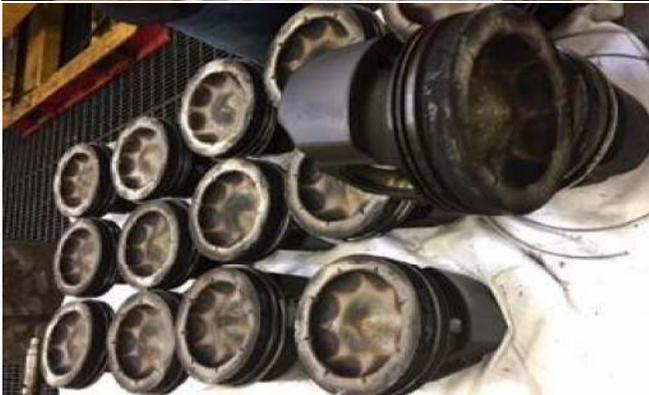
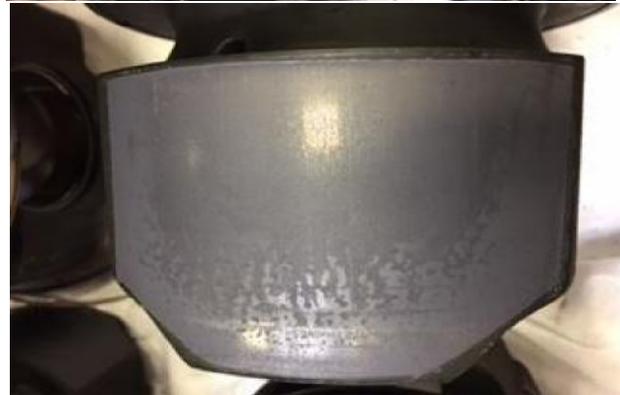
## Photos at Engine Disassembly (Pistons)

At disassembly, several other broken head bolts were found, however, the condition of the cylinder packs, pistons, rings & liners indicated significant useful life remained. Of note was the low amount of carbon buildup and the nature of the carbon was softer than previously seen, particularly in the piston ring lands, in the head valve chambers and on the valves. Oil analysis was deemed normal for an engine in an acceptable operating condition. Crankcase deposits were notably very low and in the case of normal buildup of “sludge\varnish” in the crankshaft counterweight retainer bolt holes, there was in this engine, an unusually small amount of buildup.
